# COOLING SYSTEM AND AFTERCOOLER MAINTENANCE RECOMMENDATIONS

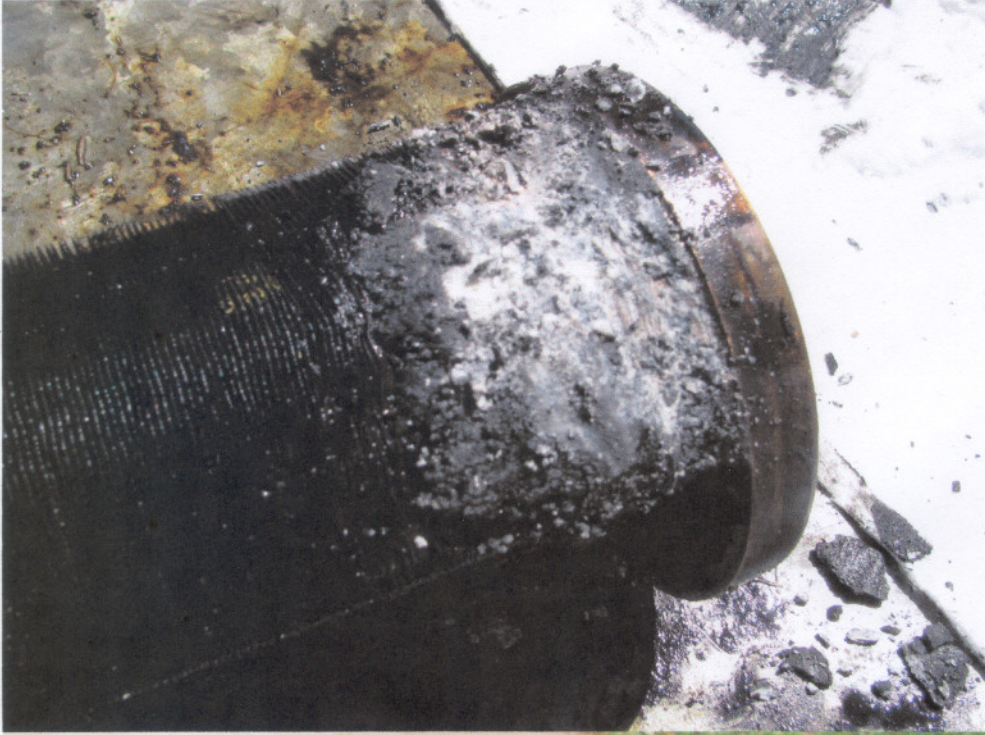
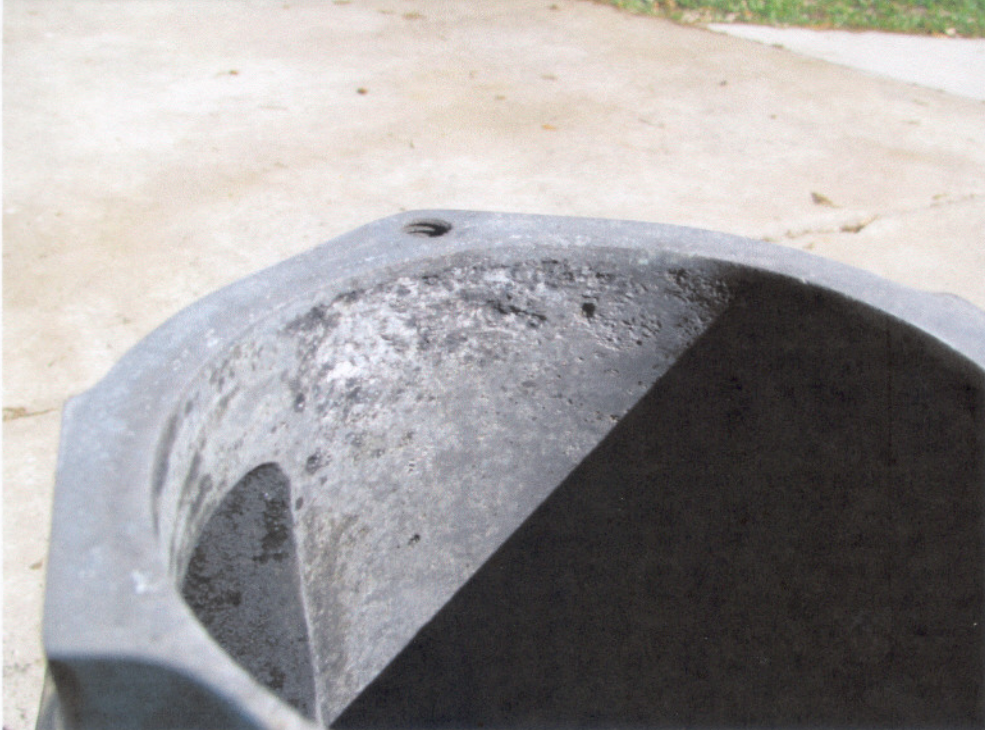
Here is a cupro-nickel core and aluminum housing out of a Cummins 450-C which had o-rings going bad or and a lack of zincs. This engine has been ingesting salt water and has extreme blow-by now due to damaged piston rings and cylinder walls. Not good for an 8 year old engine with only a little over a 1000 hours on it.

Most all aftercoolers have aluminum housings, cupro nickle or stainless core bundles, and bronze end caps all touching each other and holding salt water which cools your intake air coming from the turbo charger. Without zincs and periodical service, they fail and leak then the engine is doomed.

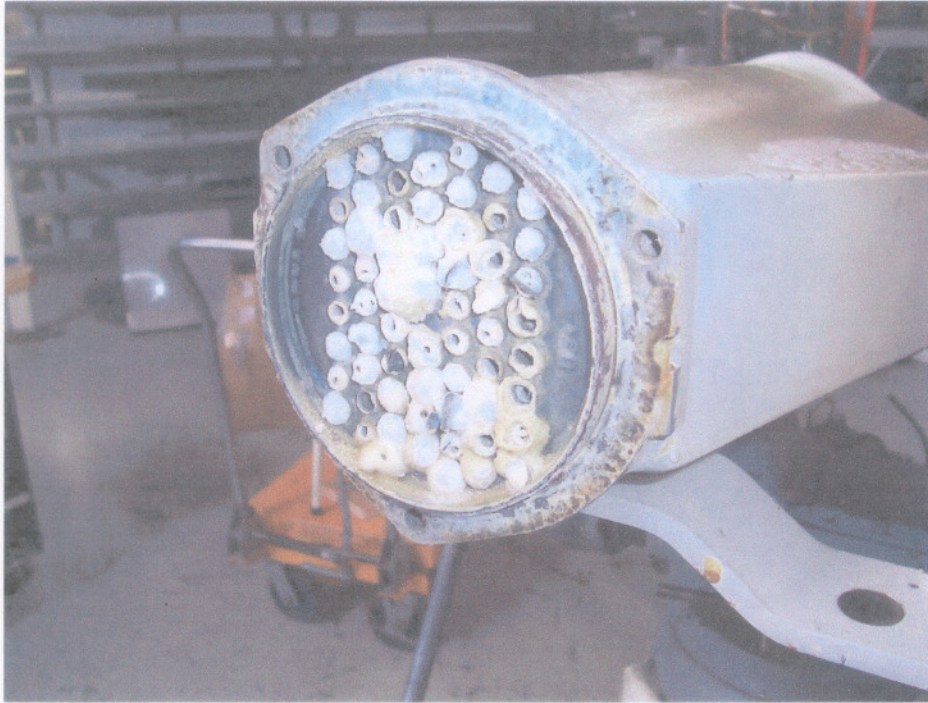
Here is the end of an aftercooler core bundle that has severe mineral deposits from drying out and causing engine to run hot .

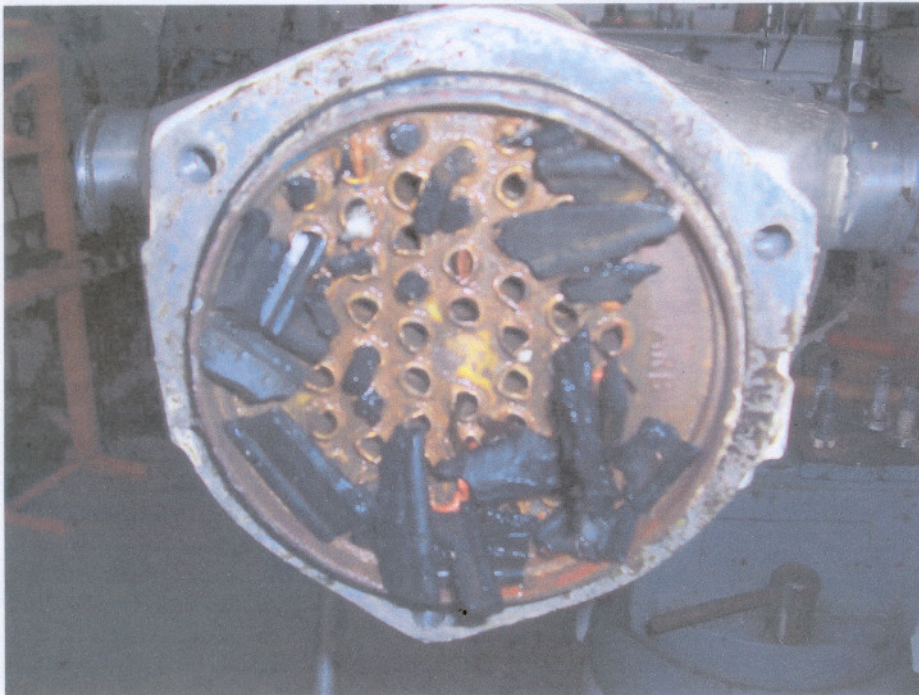
These impellor blades plugging up this after cooler is why it is important to find all the blades when you blow out an impellor. Putting in a new impellor is only half the job. This engine still ran hot.

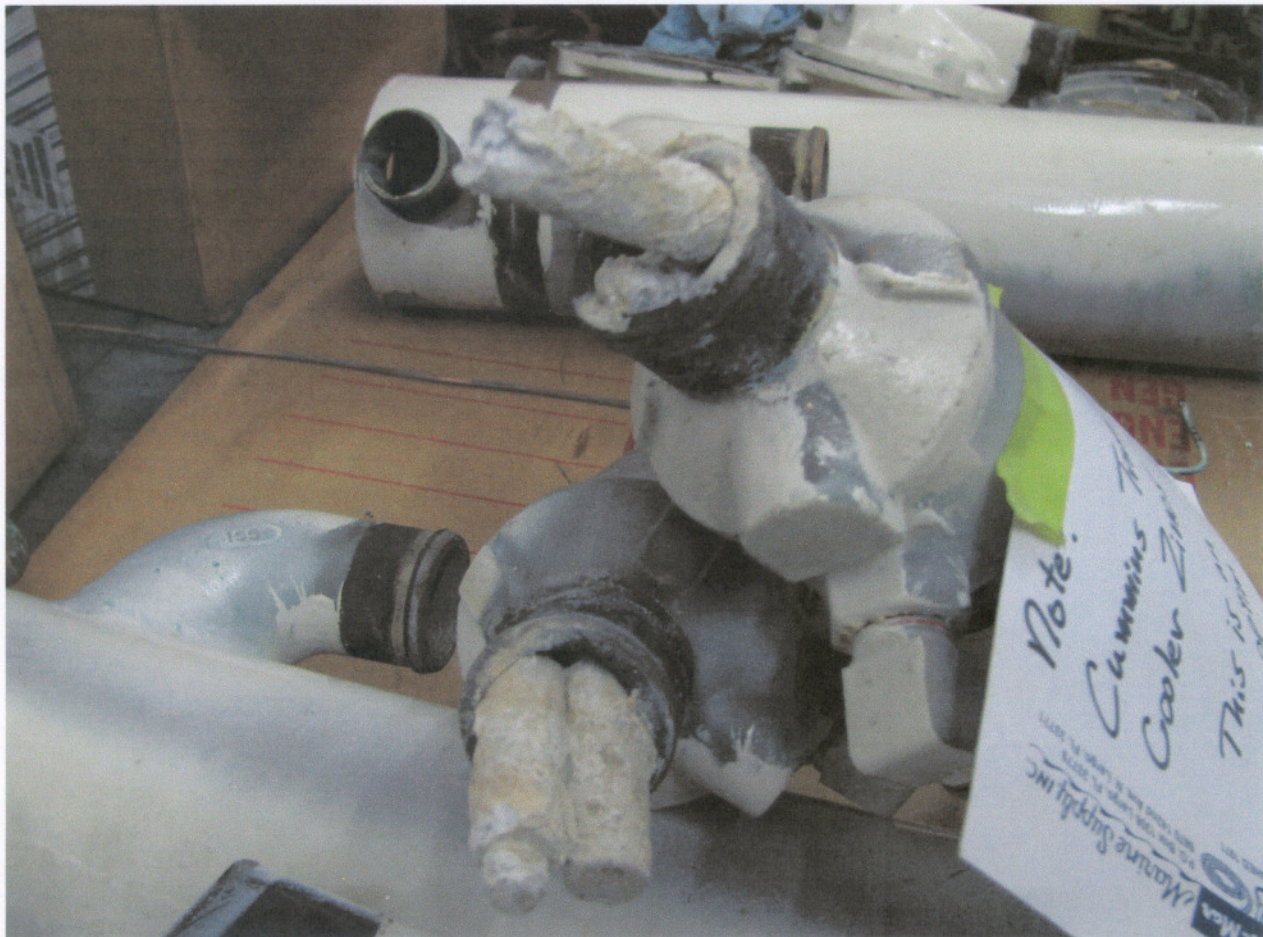
Here is what happens when you check the top aftercooler zincs and the pencil zinc does not come out with the brass pipe plug and all those zincs go somewhere. This guy had a maintenance company check his engines every month but had no clue as to why his engine was running hot or why he was paying so much for zincs. Well at least his tranny coolers were well zined.

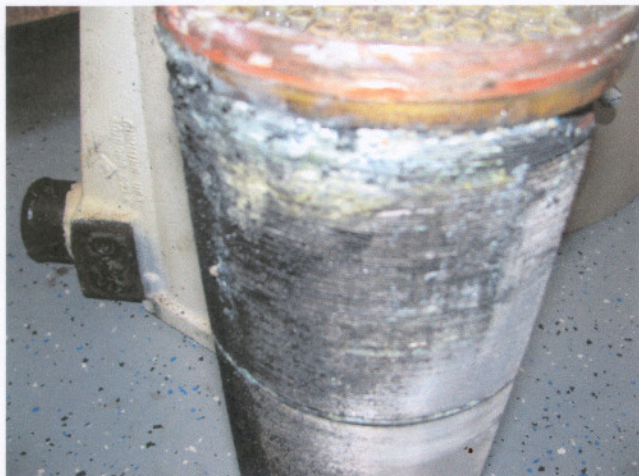
Aftercooler core from Cummins B-series that had an acid flush that damaged the o-ring seals and caused salt water to leak past them. Not good.

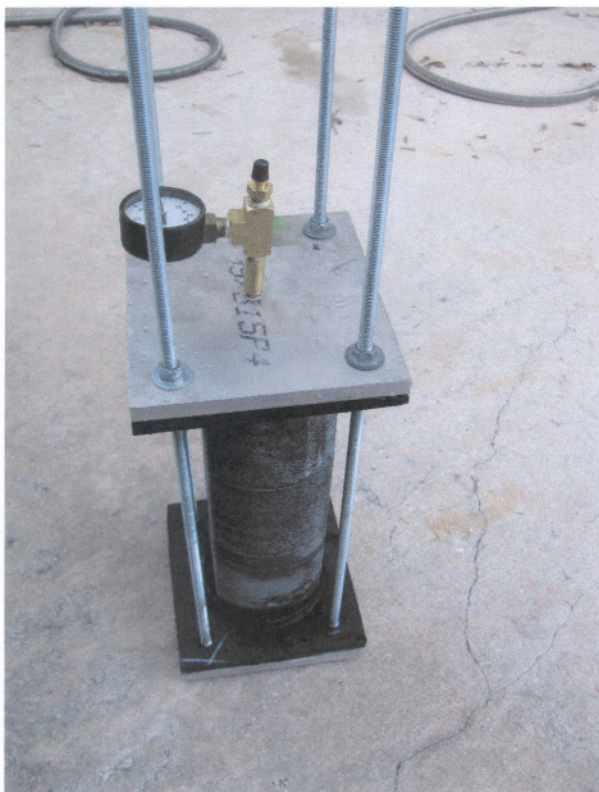
Here is a aftercooler core being pressure tested which we also submerge in a tank of water to see any minute bubbles

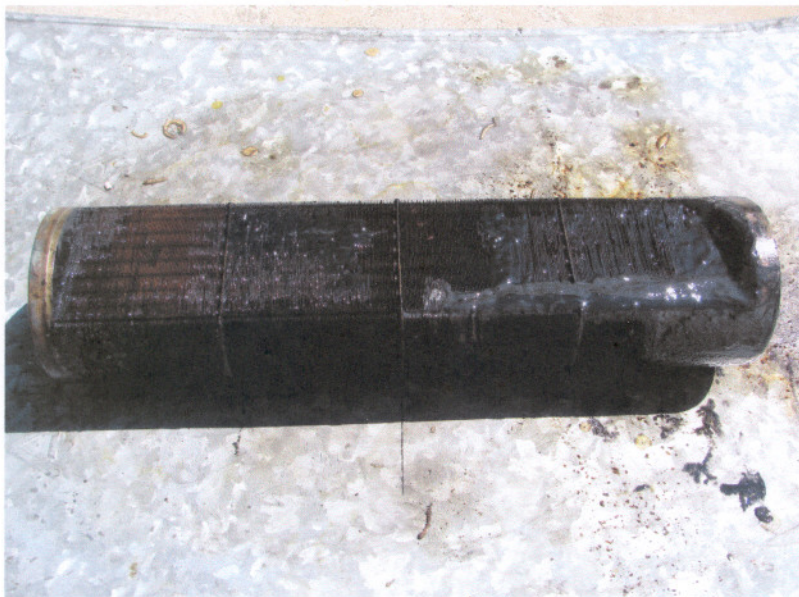
Here is an aftercooler core that is packed with oil sludge from a turbo charger that failed it's thrust bearings and seals. This engine was smoking alot and and was not getting enough air.

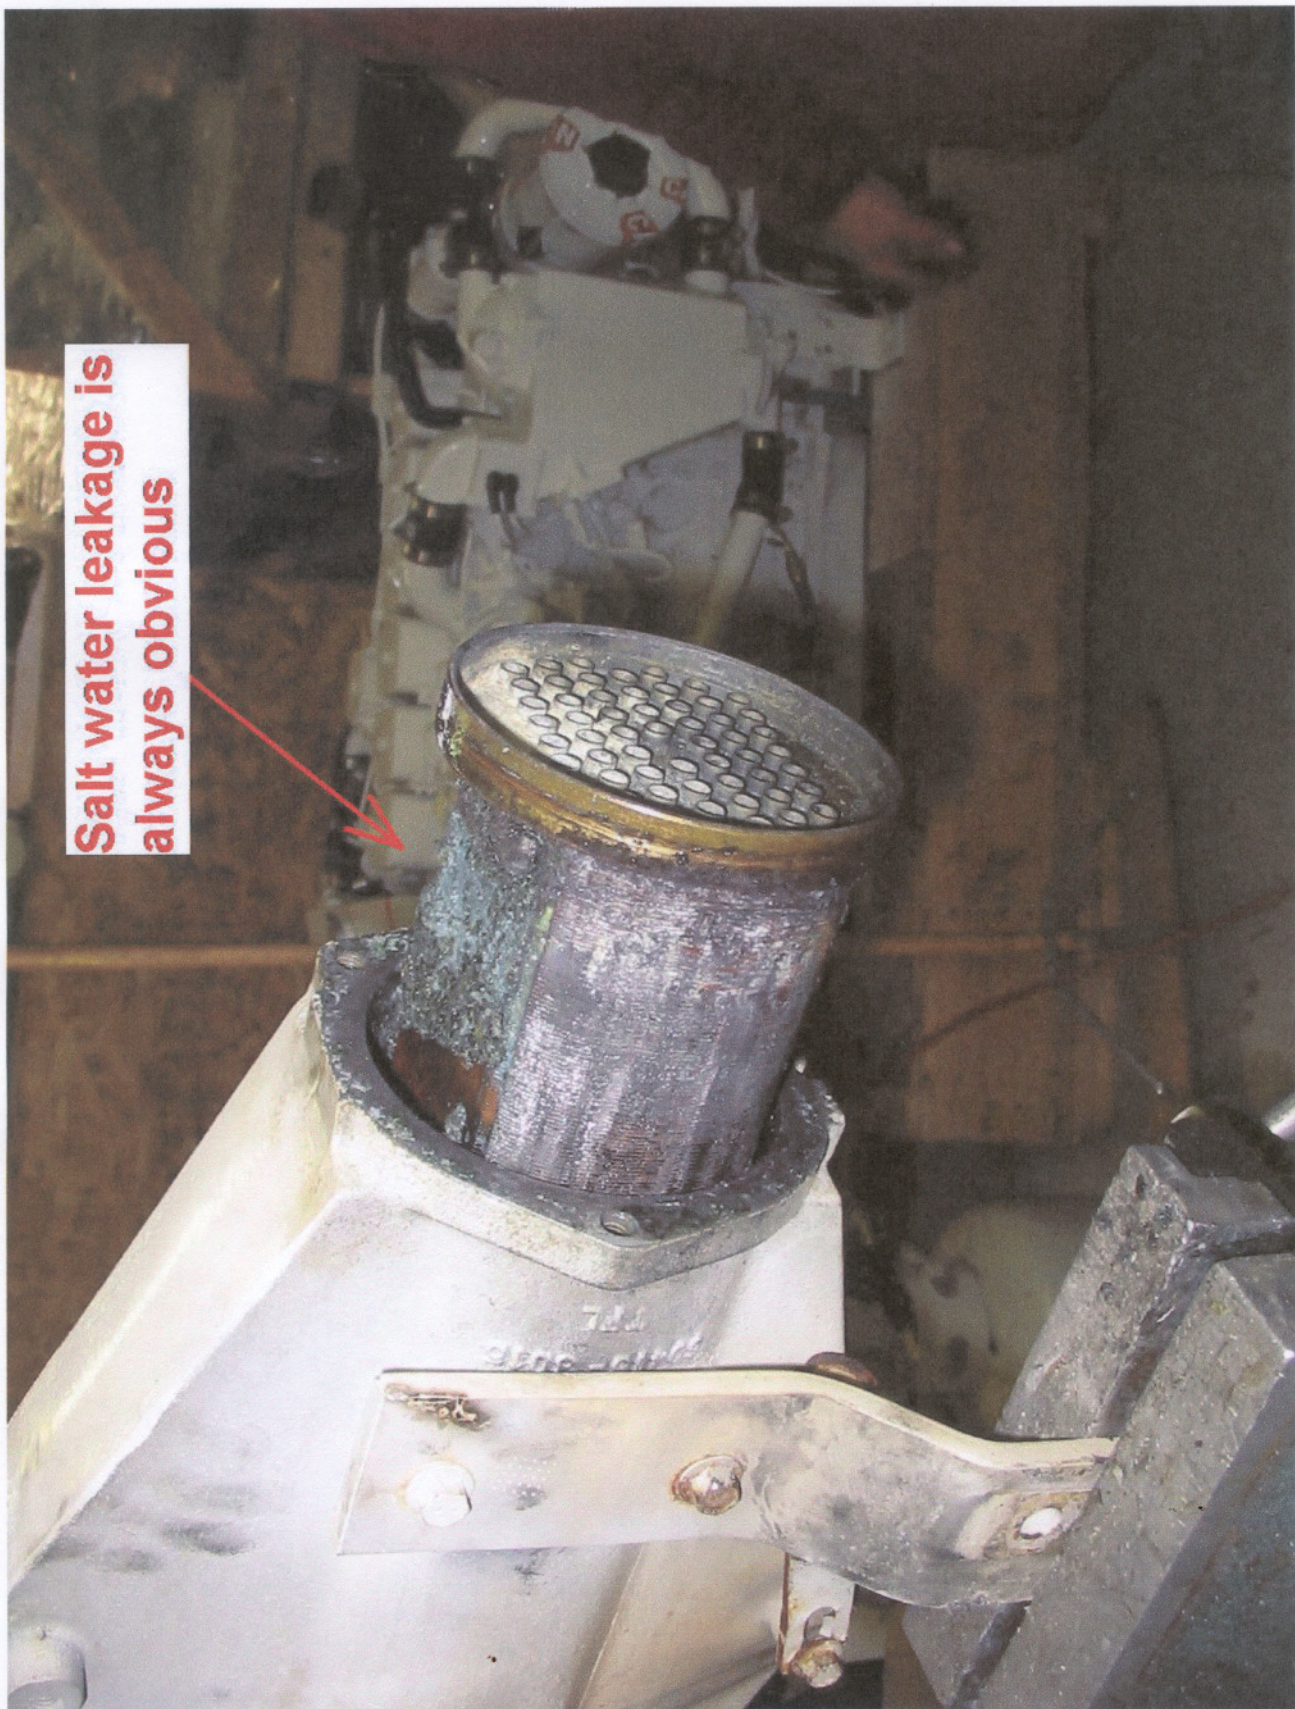
**Salt water leakage is  
always obvious**

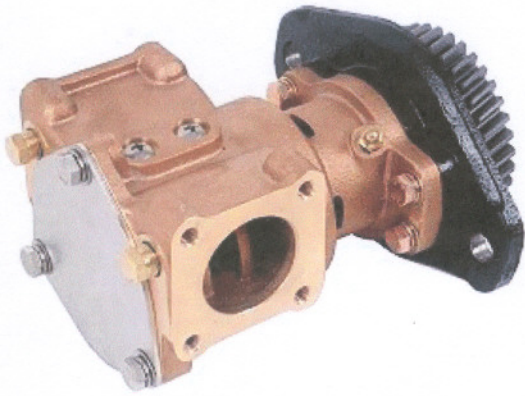
## SEAMAX Model SMX 1730 Pump

- Exclusive design for 100% "PLUG & PLAY" replacement on all Cummins B & C Diamonds
- Triple bearing design w/ ENGINE OIL lubricated bearings and "emergency lube" zerk
- "Detroit Style" mechanical water seal w/ aft-mounted double lip oil-lubed "oil seal"
- Impeller has splined naval brass inner hub for ease of replacement - NO MORE KEYS or plugs
- Made from proven seawater resistant alloys of bronze, brass & SS - no "JUNK" metals
- Redesigned front flange for easier R&R on the 6BTA Diamonds - "clears" front mount
- New cam design eliminates any chance of the dreaded "Spinning Cam Syndrome"
- Exclusive 316 SS inner wear plate & locking design - no more "Spinning Wear Plate" pump failures
- Simple rebuild using commonly available tools, bearings & seals
- Special intake and outlet ports available for "custom installs" or early engine upgrades

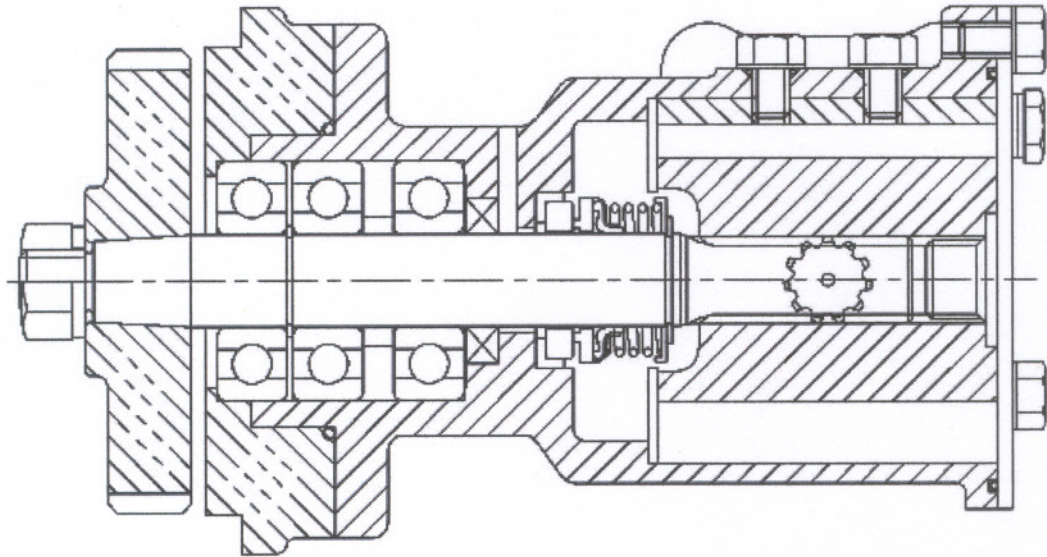
SEAMAX Model SMX 1730 Pump - Internal view
